**Township of Clearview
26/27 Sideroad, Township of Clearview
Proposed Improvements
Environmental Impact Study**

**October 2018
300034587.0000**

R.J. Burnside & Associates Limited (Burnside) was retained by the Township of Clearview (Clearview) to conduct an Environmental Impact Study (EIS) for the required road improvements to 26/27 Sideroad to address public safety issues and existing environmental impacts.

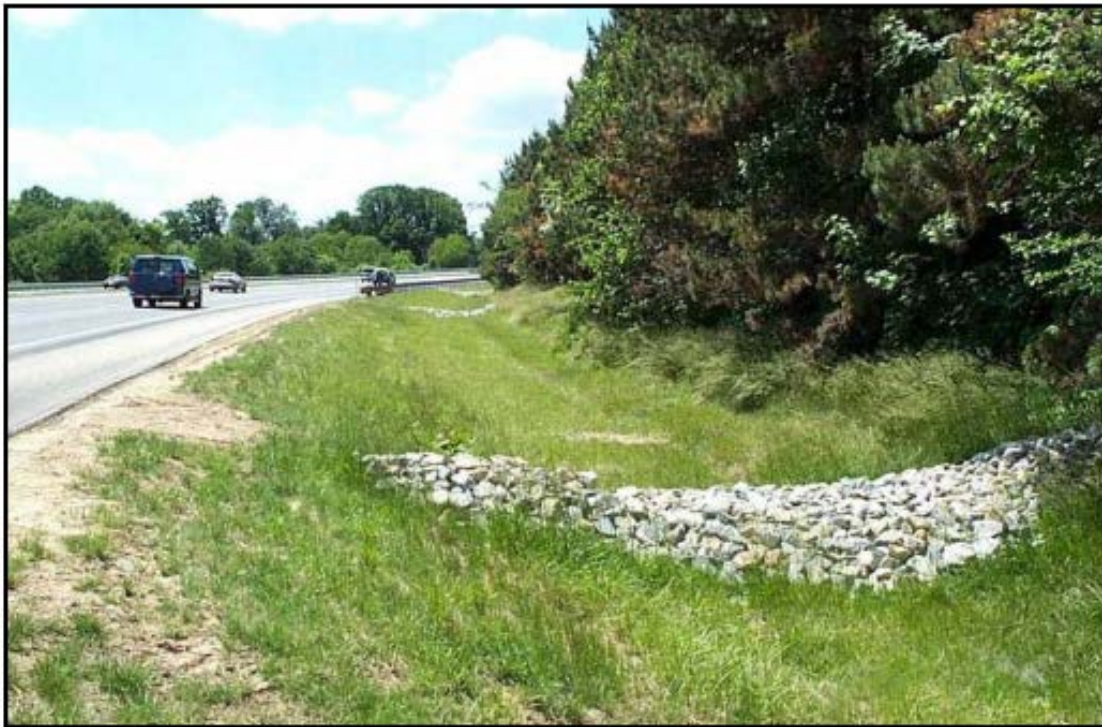
Figure 4.8.2 Enhanced grass swales feature check dams that temporarily pond runoff to increase pollutant retention and infiltration and decrease flow velocity

Enhanced grassed swales also slow down stormwater through the vegetated swale such that quiescent settling of particles can occur. Based on the CVC TRCA LID Stormwater Management Planning and Design Guide, “Median pollutant mass removal rates of swales from available performance studies are 76% for total suspended solids, 55% for total phosphorus, and 50% for total nitrogen (Deletic and Fletcher, 2006).” Furthermore, “Enhanced grass swales are well suited for conveying and treating runoff from highways and other roads because they are a linear practice and easily incorporated into road rights-of-way.” Refer to the rock check dam detail found in Appendix B, “BSD-24 DRAFT, Typical Rock Check Dam Erosion Control Device”. The note in the detail stating “100 mm of 50 mm clear stone cover” will be revised in the construction contract to reflect cover with a mixture of 50 mm clear stone and 150 to 300 mm stone to ensure the check dams stay in place under high flow conditions. The rock check dams are to be employed in series down the slope as shown in the photo above. The series will be located in all areas with ditch slopes exceeding 4%.

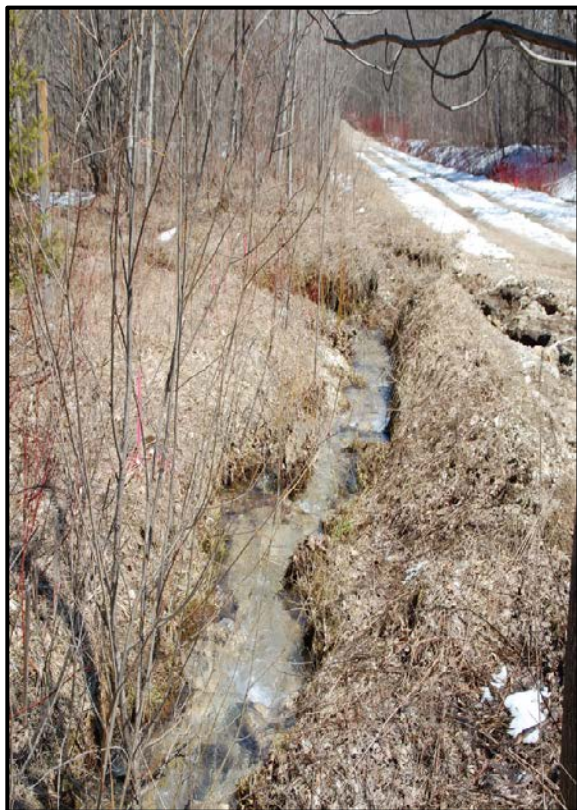
Photograph 11

Section of Tributary A that is proposed to be realigned (April 14, 2016).

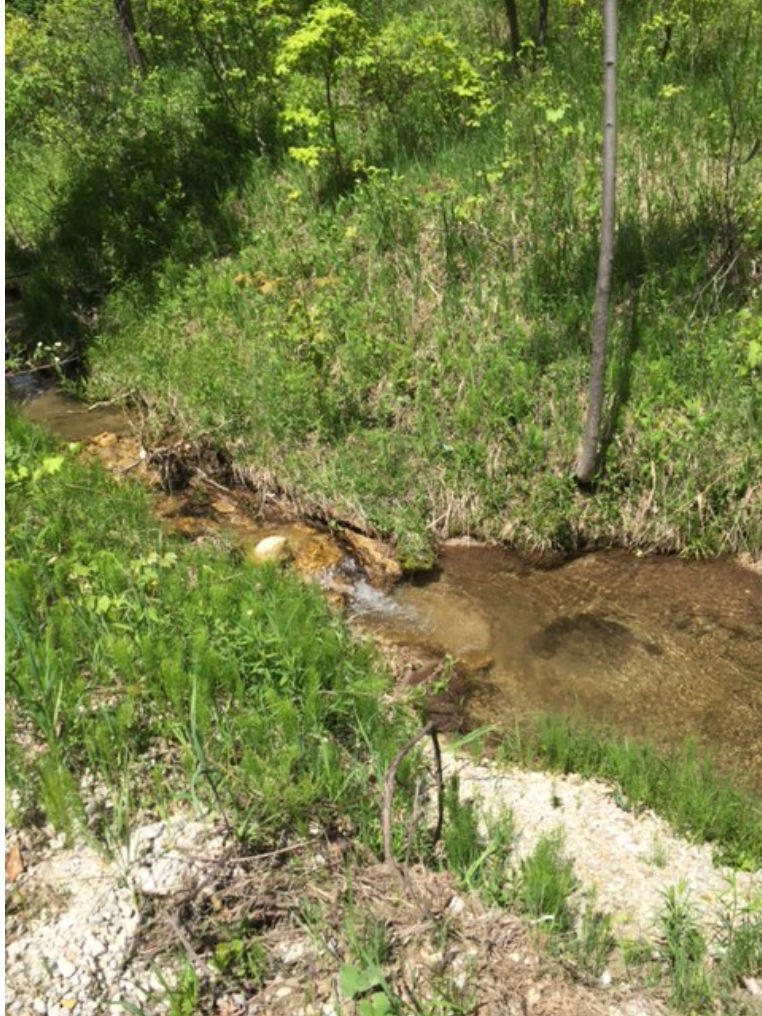
Photo 1 - Chute and pool morphology

In summary, fluvial geomorphological input was provided into the proposed channel realignment design of a tributary to the Pretty River. Overall, the nature of the design is minor and can be easily implemented. The existing channel dimensions, substrate and bank conditions will be replicated in the proposed realigned channel. Given the nature of the creek and the setting, it is felt that the work is appropriate and provides benefits in terms of natural geomorphic function of the tributary.

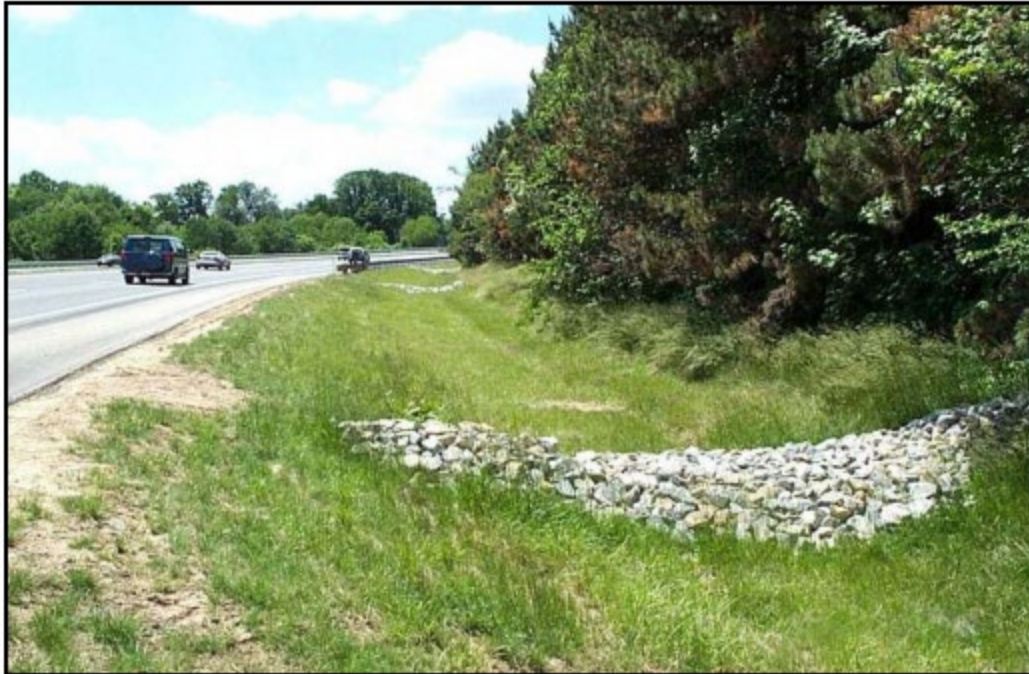
Figure 4.8.2 Enhanced grass swales feature check dams that temporarily pond runoff to increase pollutant retention and infiltration and decrease flow velocity

Enhanced grassed swales similarly increase stormwater contact with vegetation and soil. They partially rely on infiltration to achieve quality control of stormwater. Enhanced grassed swales allow stormwater to infiltrate as they detain a portion of the stormwater behind check dams and allow it to infiltrate. Refer to Figure 4.8.2 excerpted from the CVC/TRCA LID Stormwater Management Planning and Design Guide, a photo of an enhanced grassed swale.

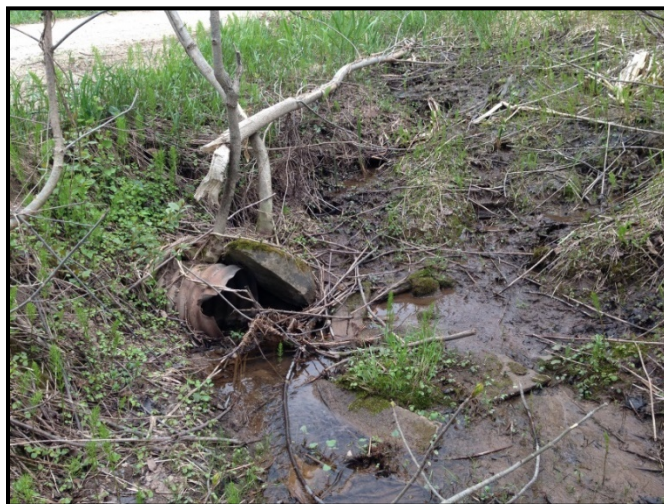
Photo 3: Inlet of culvert conveying Tributary D, upstream (south) of 26/27 Side Road (May 22, 2014)
