REPORT

GEOLOGICAL ASSESSMENT IN SUPPORT OF PROPOSED NIAGARA ESCARPMENT PLAN REDESIGNATION

CHELTENHAM QUARRY - 14504 MISSISSAUGA ROAD, CALEDON

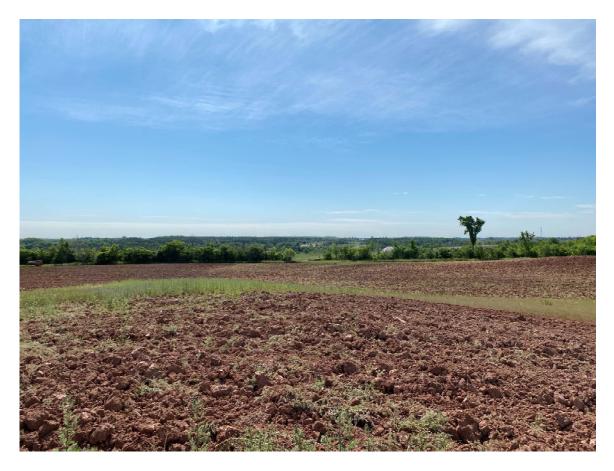
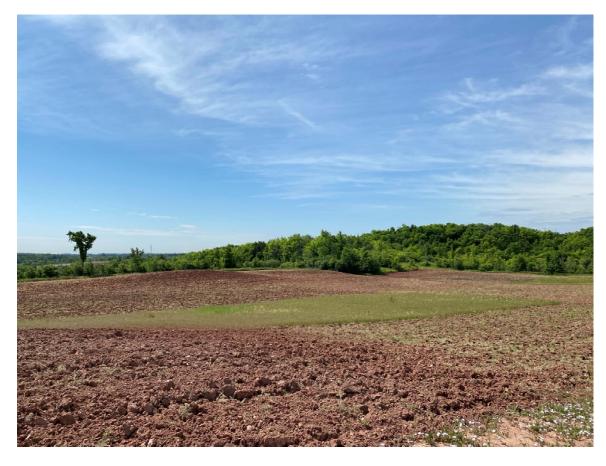
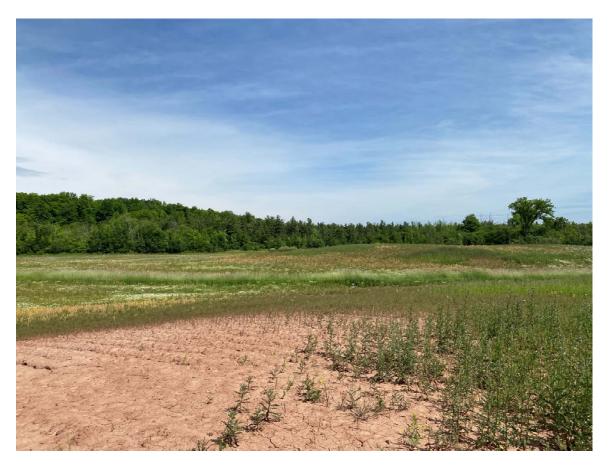
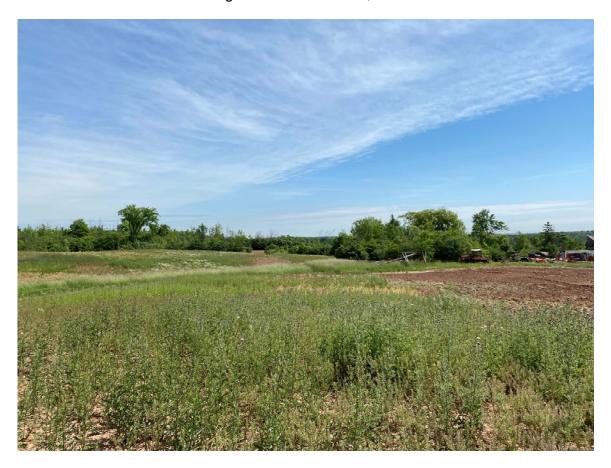
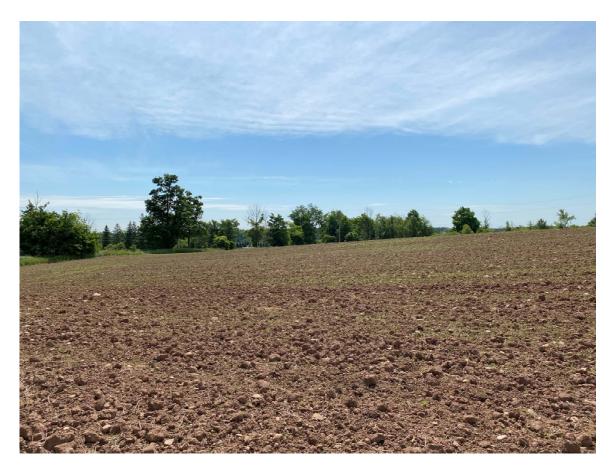
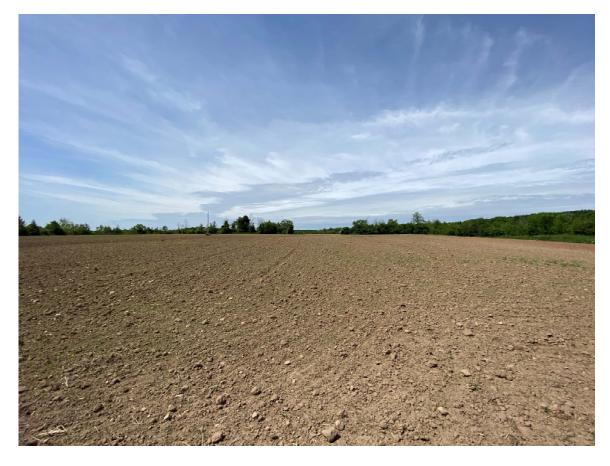
The topography on the site (Figure 3) is flat or gently undulating (Figures 7 to 12), with a typical ground slope of less than 5 degrees (Figure 6) and a maximum observed slope of less than 10 degrees.

Figure 7 – View from center of the site looking southwest – June 20, 2022

Figure 8 – View from center of the site looking northwest – June 20, 2022

Figure 9 – View from center of the site looking northeast – June 20, 2022

Figure 10 – View from center of the site looking southest – June 20, 2022

Figure 11 – View from east of the site looking south – June 20, 2022

Figure 12 – View from east of the site looking west – June 20, 2022

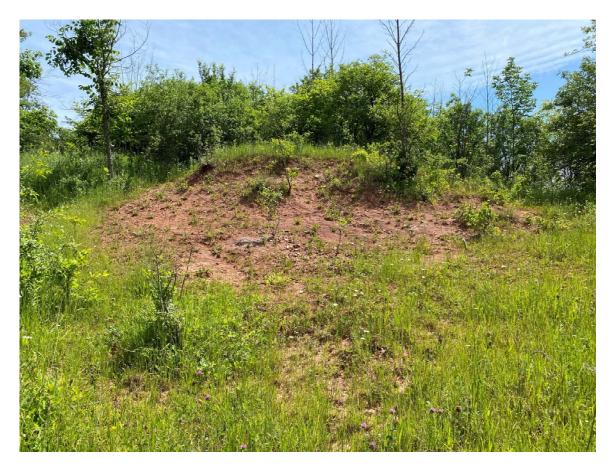
Although Quaternary (surficial) geology mapping for the site indicates it has been predominantly classified as Palaeozoic bedrock at surface (Figure 5 – Soil Type 3), no bedrock outcrop was observed during the site visit. The ground surface was observed to be predominantly covered by red-brown silty to clayey till (Figure 13) suggesting it would more appropriately be mapped as Type 5d – Glaciolacustrine-derived silty to clayey till, similar to the property immediately east of the site.

Figure 13 – Typical clay soil exposure in north central part of the site – June 20, 2022

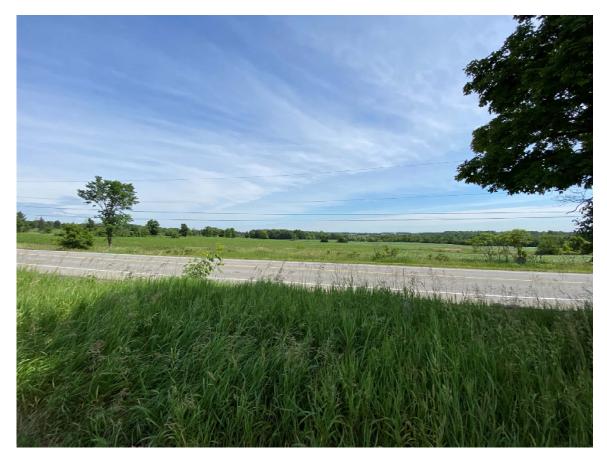
In general, the geologic and terrain conditions on the site were observed to be quite similar to that observed on the property immediately to the east of the site (Figure 14), which is designated as Escarpment Rural Area.

Figure 14 – View of neighbouring property immediately east of Mississauga Road – June 20, 2022
